Project Voss FRR Addendum Purdue University 2021

Purdue Space Program

1 Summary of FRR Addendum

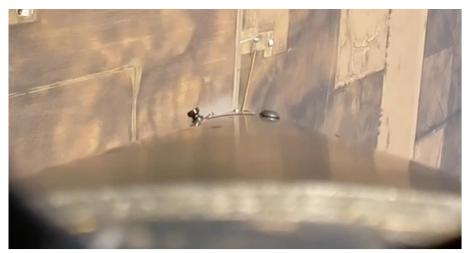
The target apogee for the flight was 4100' AGL. During the Payload Demonstration Flight, the rocket apogee was close to the target apogee. This would have eliminated the need for the ABCS to deploy at all. However, this cannot be directly verified due to a lack of foresight and system design; there was no method of logging data during flight for the ABCS system. In a test conducted after the Payload Demonstration flight, the avionics data was streamed to the ABCS system in a "software-in-the-loop" simulation to determine what maximum angle the ABCS would have tried to open to during the flight. This angle was extremely small—only 4 degrees—but it would have been noticed with the aft-cam footage. This was verified by actuating the system to 4 degrees and checking the camera feed post-flight. However, you could not see the Aeroplate, which was in the field of view (FOV) of the aft-cam due to a mechanical jam of that singular Aeroplate at 4 degrees. Additionally, the rail button also distorted the FOV of the aft cam further. This situation is highly unfortunate, but the ABCS team has been able to successfully employ use of the aft-cam footage to analyze the flight, despite the fact that this system was not intended to help do so.

Figure 2.3: POV of the Aft-Cam during Vehicle Coast

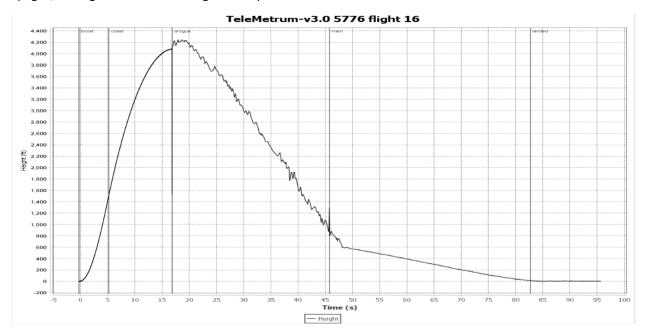
Figure 2.4: Altitude Data Plot of PDF Flight (Courtesy of the Avionics Team)

In contrast with the Vehicle Demonstration Flight, the Payload Demonstration Flight's launch trajectory was significantly tilted to 16 degrees after the rocket exited the boost phase due to a steep inclination of the pad. This led to the assumption that the ABCS did deploy to 4 degrees, causing a drag force on the side of the rocket opposing the camera providing video feed, possibly explaining the additional turn of the rocket as seen from the aft cam footage. The uneven force distribution is caused by a manufacturing defect in the ABCS, where one pad gets slightly stuck before "popping" out at around 8 degrees. Again, in a series of unfortunate events, the pad that was found to get stuck at 4 degrees happens to be the pad in the line of sight of the camera.

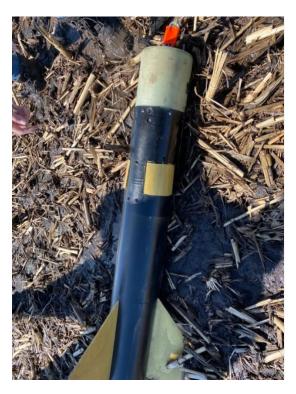
The team has debated whether this is enough evidence to verify that ABCS actuated during flight. To conclude, there is a significant amount of evidence that points to the airbrakes functioning during the Payload Demonstration flight. Considering that the ABCS has successfully satisfied its requirements in both integrity, stability, and altitude accuracy, the team must consider this demonstration a plausible success.

Figure 2.5: ABCS Landed Post-Flight

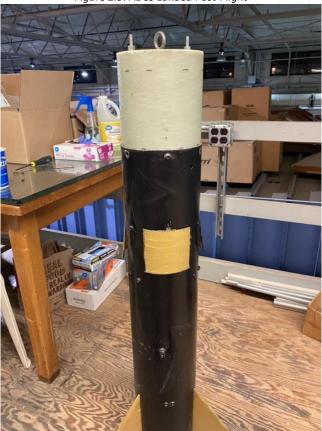
Figure 2.6: ABCS Post-Flight Actuation Test at 4 degrees

Figure 2.8: ABCS Post-Flight Actuation Test Aft Camera Optimal Radial Location Representation
As seen in the above images, 2 Aeroplates are visible when actuated at 4 degrees. One of them is not visible due to jamming of the paddle strut with the ABCS coupler caused by insufficient actuation clearance between the two components.

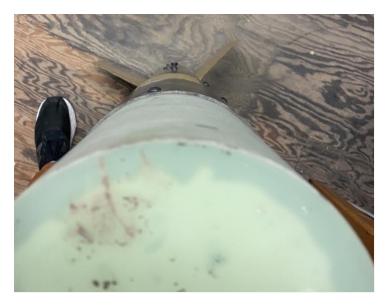
Figure 2.7 ABCS Post-Flight Actuation Test Aft Camera Representation

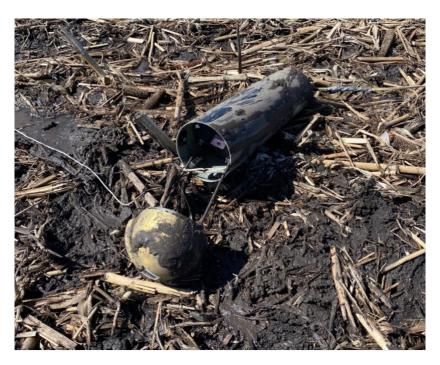
The R&D software worked as expected during VDF, but not PDF. The reason behind this is that the damaged drogue parachute caused much higher forces to be exerted on the system than expected during descent. For reference, during descent under the drogue parachute, the system logged approximately 2.2g of force. That is over twice the maximum force that the system expected during that period of descent. Due to this, the system believed that the main parachute deployed at that point and began using the RTC and accelerometer of the system to calculate its altitude. The main parachute was projected to exert 2g of force on the system, hence why it thought the main parachute deployed. This was a built-in safety feature in case the altimeter failed during flight. Unfortunately, the safety feature caused the system to attempt to release at an altitude of approximately 2923 feet. To resolve this issue, the code will be reevaluated, and the team will determine the best course of action, potentially removing the safety feature being the altimeter has not failed during any formal or informal test and has worked during both flights so far.

Mechanically, the R&D bay failed to fully extend which prevented the deployment of the lander while descending. The team believes that the R&D pizza table experienced unexpected forces during descent, primarily from the increased load from the main parachute due to the drogue not deploying correctly. It is also possible that the addition of the elastic band could have caused the failure to fully extend. Unfortunately, the onboard cameras didn't provide enough information to accurately determine the exact reason the Pizza Table failed to fully extend.

Figure 2.12: Post-Flight Payload Bay with R&D Bay Open

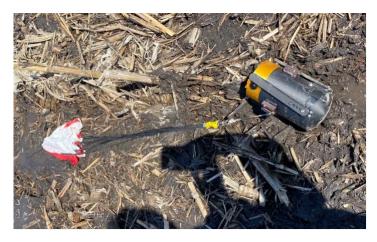
Unfortunately, as the R&D failed to fully deploy the Lander, no meaningful results can be determined according to the operation of the D&L System. The Lander fell with the rocket, so recording the descent time would not determine the functionality of the Lander's parachute. Because the Lander did not leave the R&D Bay, the parachute stayed in the deployment bag as intended. Of note, the Lander was found approximately 11' from the nearest element of the launch vehicle.

Figure 2.13: Lander Deployed after Dragging Post-Flight

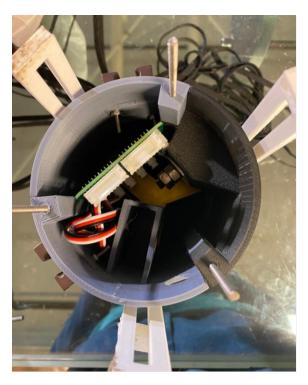
Due to several circumstances, including delayed orders and the loss of critical personnel resources, the LCS was not able to be fully completed in the desired state. There were several features of the LCS that were not implemented and several last-minute modifications that needed to be made. First, the PCBs arrived, but the team ran into several problems assembling components onto the PCBs. The critical BNO085 and BMP390L sensors were the primary issue. Both sensors proved to be extremely difficult to solder on despite using equipment available from the BIDC electronics lab. Ultimately, the BMP390L was not functioning at the time of launch and the team believes

this is a result of a hardware issue that the team did not have time to debug. The team improvised and soldered a BMP388 breakout board to the primary board to use in place of the BMP390L. The BMP388 uses the same API as the BMP390L so this change did not require any changes to code, in fact much of the code was developed using the BMP388.

Figure 2.14: Final Lander LCS Overhead View (No Battery Installed)
