Project Voss FRR Addendum Purdue University 2021

Purdue Space Program

1 Summary of FRR Addendum

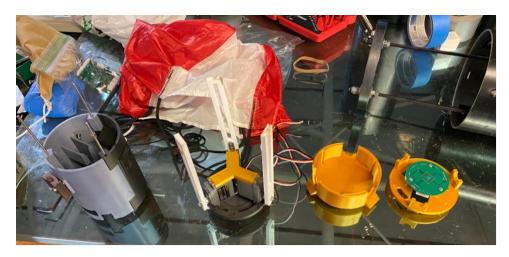
Additionally, the GCS was not in its active state. Although some of the software was completed for it, such as image stitching, PICS was not completed sufficiently and therefore the GCS was not able to be utilized in the desired manner.

Figure 2.11: PLS Family Photo (Left to Right: Main Body, SOS, Cupola Top, PICS Plate, Pizza Table Assem.)

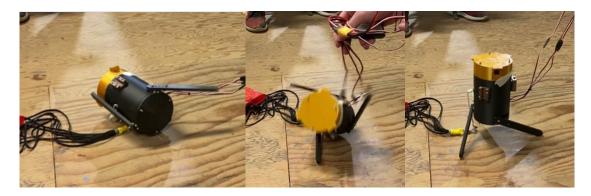
Upon landing, the Lander initializes all legs to 0 degrees and allows 5 seconds to pass before triggering the next sequence. However, due to complications with interfacing the IMU, the ability of the final detection of orientation and self-correcting procedure was unable to be completed. Without the ability to detect if the Lander has fallen into an unfavorable orientation, the team decided that the Lander would continue to perform a "kick" function with each of its legs, one by one, to allow the Lander to roll down any hill or slope it is potentially positioned on. After each kick is performed, the Lander would actuate all three legs to the same angle and stand itself upright. Should the Lander be positioned on a flat surface after performing the kicking sequence, this sequence would stand the Lander up perfectly vertical and has been tested and proven to be effective at transitioning the Lander to a stable initial standing position. Future additions to this sequence will involve correcting from the stood-up position to 5 degrees from vertical.

Figure 2.15: Successful Test of the SOS Stand-Up Procedure (Left to Right: Kick, Stand-Up, Standing)
